AFRL-ML-WP-TR-2000-4154

**EFFECT OF SURFACE PREPARATION ON
FATIGUE DURABILITY OF BONDED
COMPOSITE REPAIR PATCHES
VOLUME 6 – DELIVERY ORDER 4, TASK 1**

**D. Robert Askins
University of Dayton Research Institute
300 College Park Avenue
Dayton, OH 45469-0130**

FINAL REPORT FOR PERIOD 01 MAY 1998 – 30 AUGUST 1999

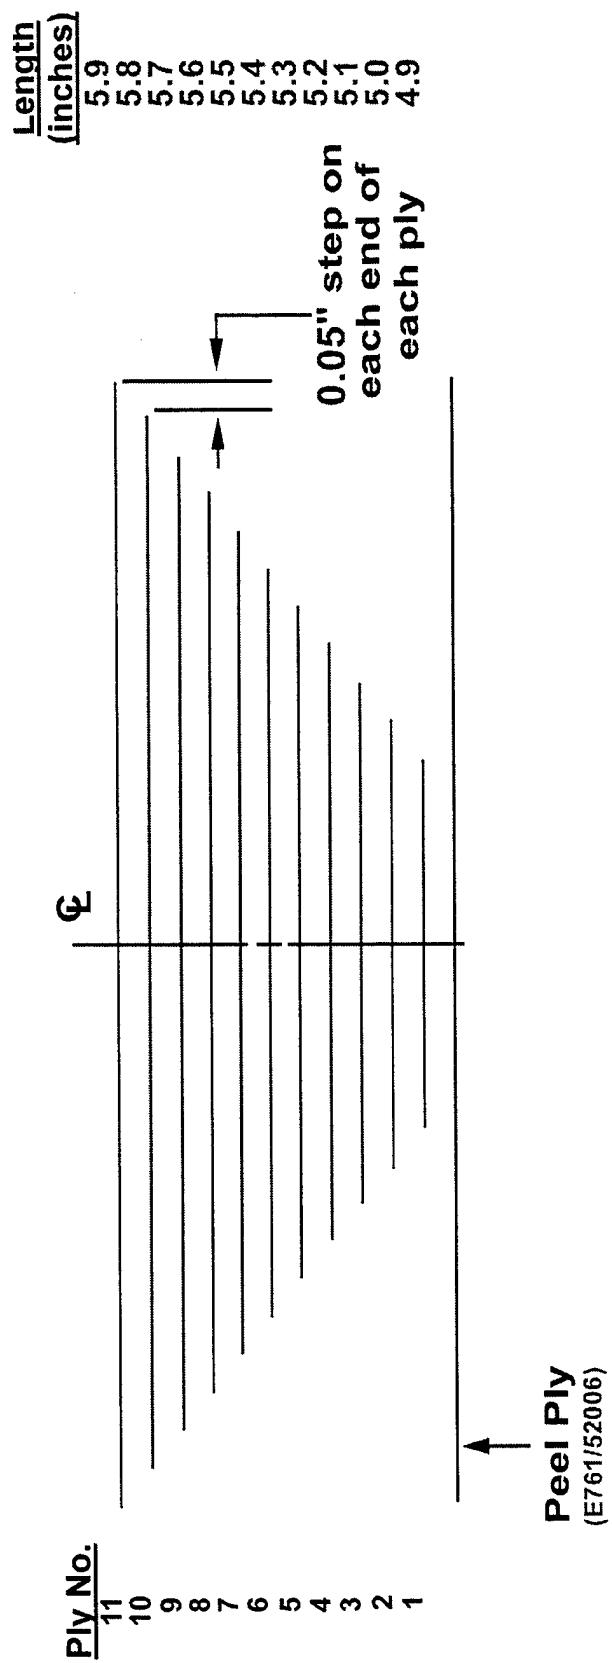
Figure 2. Longitudinal Cross-Section of Boron/Epoxy Composite Patch

It should be noted that there were two exceptions to normal patch design practice. First as illustrated in Figure 2, there was a 1.27-mm (0.05-inch) drop off for each ply on each end of the patch. This corresponds to an end taper of 6° (10:1 ratio of drop-off length to ply thickness) and is considerably more abrupt than is generally recommended (30:1 or $\sim 2^\circ$). This abrupt ply drop-off rate was used to magnify the peel stresses at the ends of the patch. This would place a more severe demand on the bond strength and on the resistance of the bond to environmental attack. It was felt that this would enhance the discrimination between the "good" and "inferior" surface preparations. Second, the length of the constant thickness portion of the patch was double the length suggested by Baker ($12/\beta$ rather than $6/\beta$). Both of these exceptions were specified by WR-ALC/TIEDD as a means of increasing the likelihood of a debonding failure along the bondline.

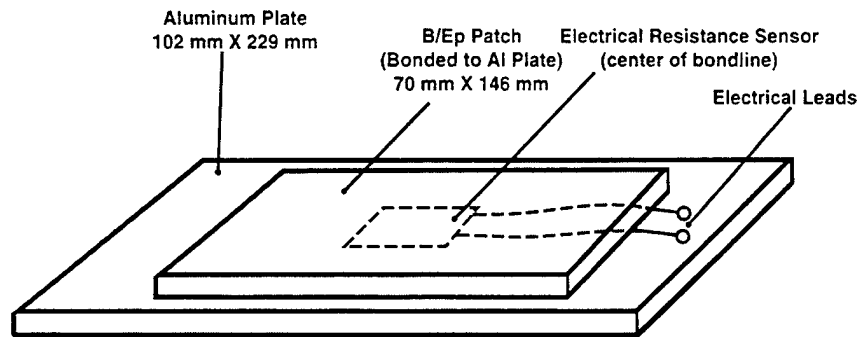
Figure 6. Moisture Sensor Embedded in Bondline Between B/Ep Patch and Aluminum Plate

specimen was utilized to determine how long would be required for the center of the bondline to reach moisture equilibrium. An electrical resistance sensor, 0.13-mm (0.005-inch) thick, 12.7-mm (0.5-inch) wide, and 25.4-mm (1-inch) long, was embedded in a dummy sample to track moisture pickup. The sensor resistance changes as the moisture content of the environment changes. By aging a sample with an embedded sensor until the resistance stops decreasing and levels off, one can determine how long it takes for the sample to reach an equilibrium moisture condition. While this does not necessarily provide a quantifiable measure of the actual moisture content, it does indicate how long it takes for the moisture content to equilibrate.

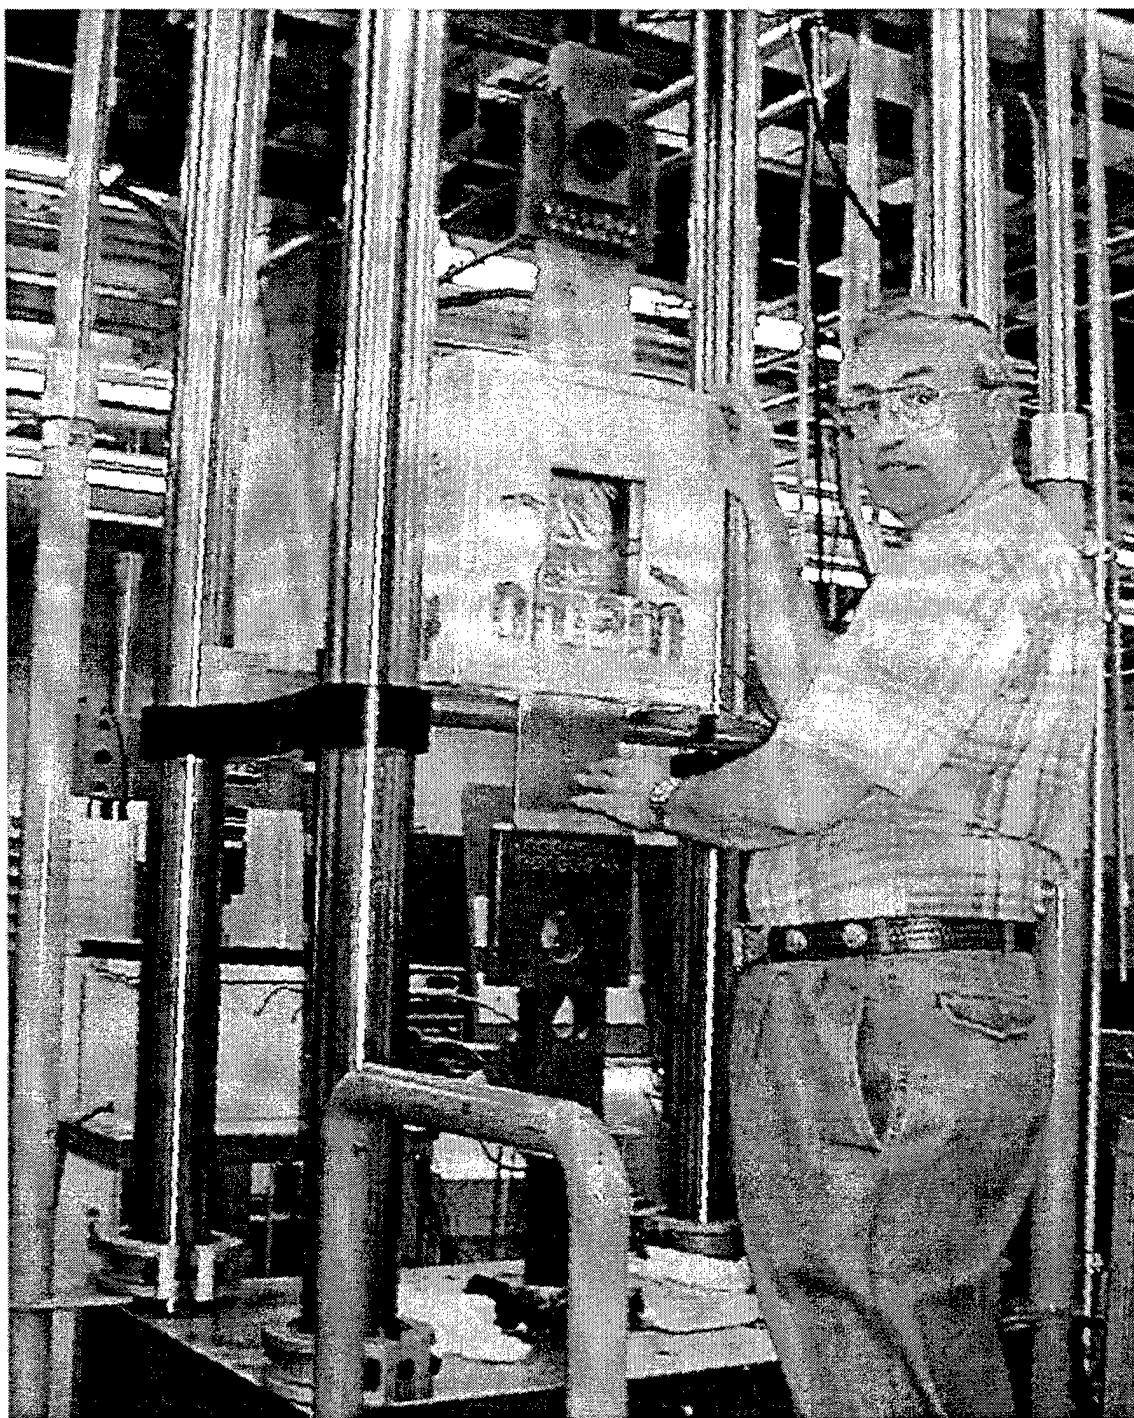
Figure 8. Test Setup for 49 °C (120 °F) Tests

The fatigue tests consisted of constant amplitude, tension-tension loading, at a frequency of 1 Hz, with a minimum/maximum stress ratio of either 0.1 or 0.5. The maximum stress in each test was 276 MPa (40,000 psi) and the minimum stress was either 27.6 or 138 MPa (4,000 or 20,000 psi). Table 3 in Section 2 lists the test matrix for each surface preparation investigated during this program. The three test conditions were 22 °C (72 °F) on specimens that were not humidity-aged and 22 and 49 °C (72 and 120 °F) on specimens that had been humidity-aged at 71 °C (160 °F) and 95-100 %RH for at least 22 weeks. Figure 8 illustrates a 120 °F test specimen mounted in the fatigue machine.

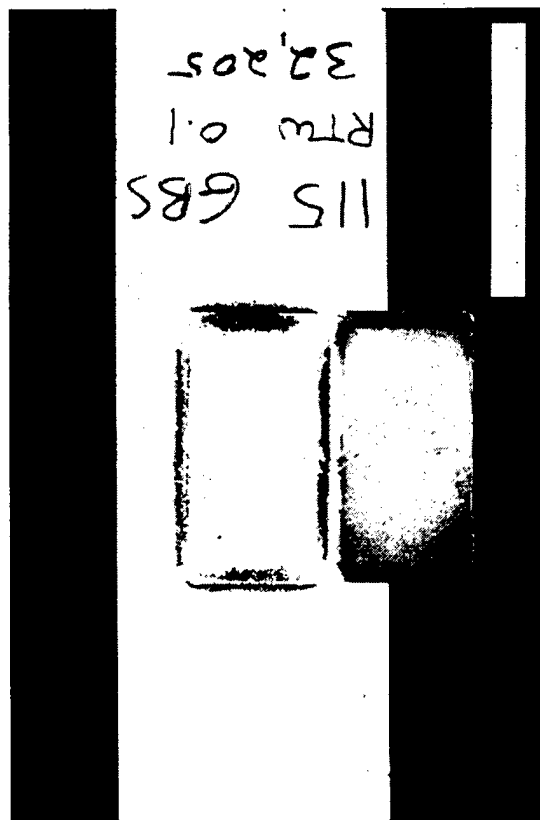
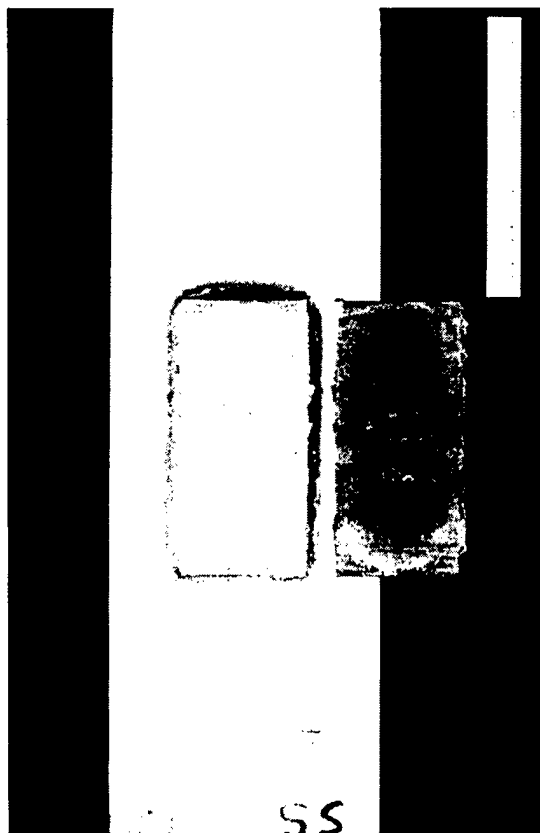
Figure 10. Interfacial Failure Modes Observed in Fatigue Tests

- 1. Cohesive failure within the adhesive layer is designated as (C).
 - 2. Interfacial failure between the adhesive and the primer is designated as (I_{AP}).

- 3. Interfacial failure between the adhesive and the unprimed metal is designated as (I_{AM}).

Interfacial Failure Between Primer and Adhesive, I_{ap}

Interfacial Failure Between Metal and Adhesive, I_{ma}

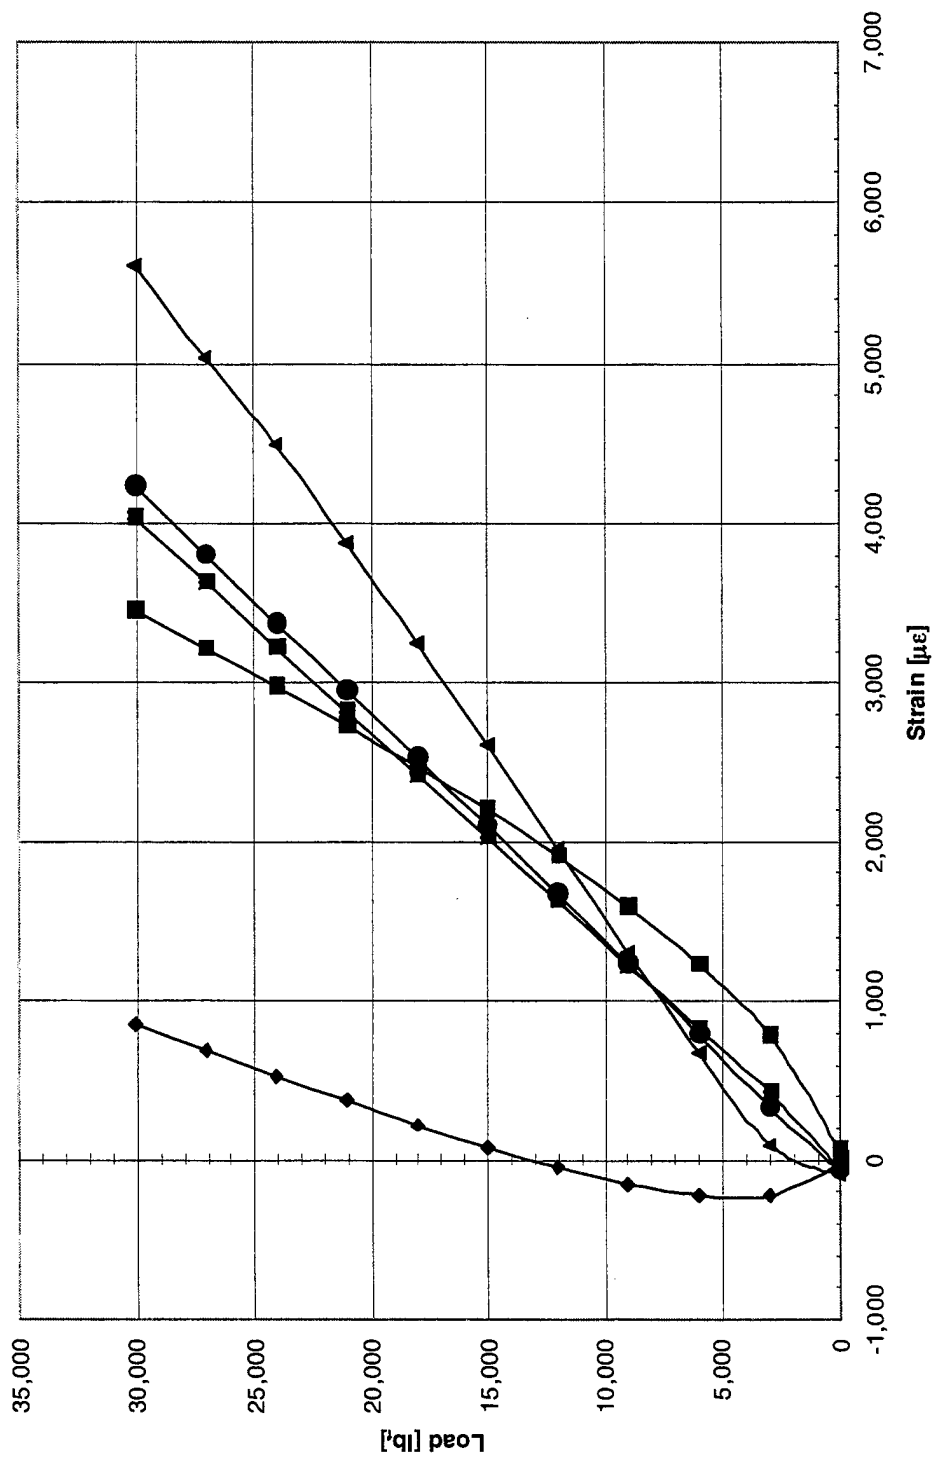
Figure 11. Initial Load-Strain Survey for Panel 111; SS Surface Preparation

The initial behavior of gage 2 is the reverse of gage 1. Since it is mounted on the concave surface of the patched panel, the initial straightening load causes it to display an exaggerated tensile strain until the panel has been straightened out. After that, the rate of strain growth exhibited at this location is reduced relative to the far-field gages (4 and 5) because of the influence of the composite patch.

Panel 111
0 cycles

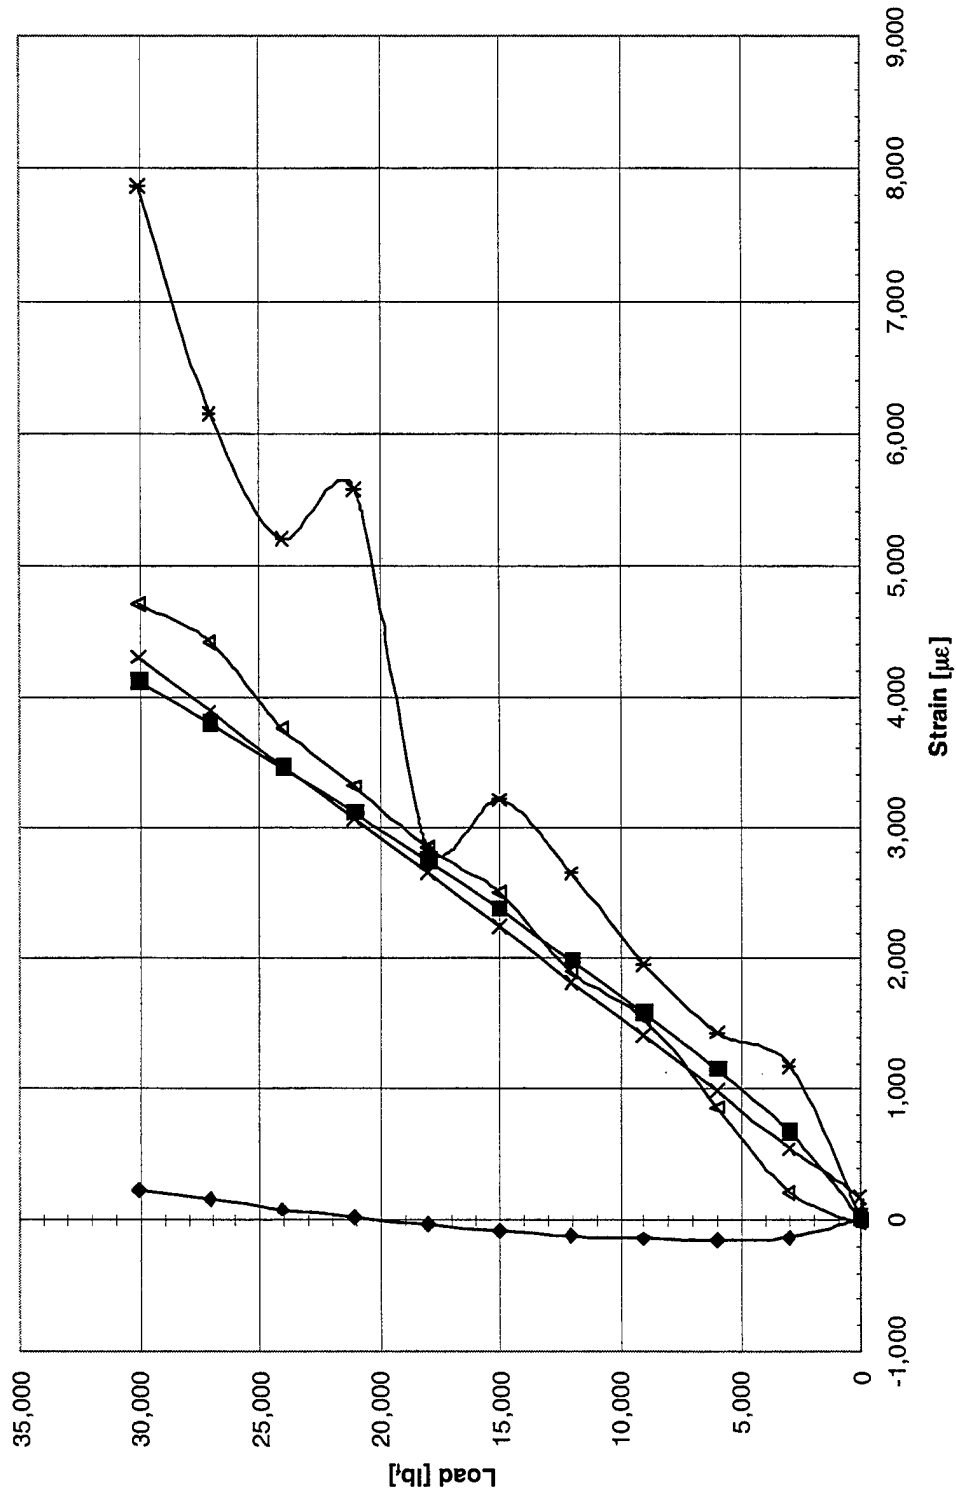
Figure 13. Load-Strain Survey for Panel 111 After 20,000 Cycles; SS Surface Preparation

Panel 111
20,000 cycles

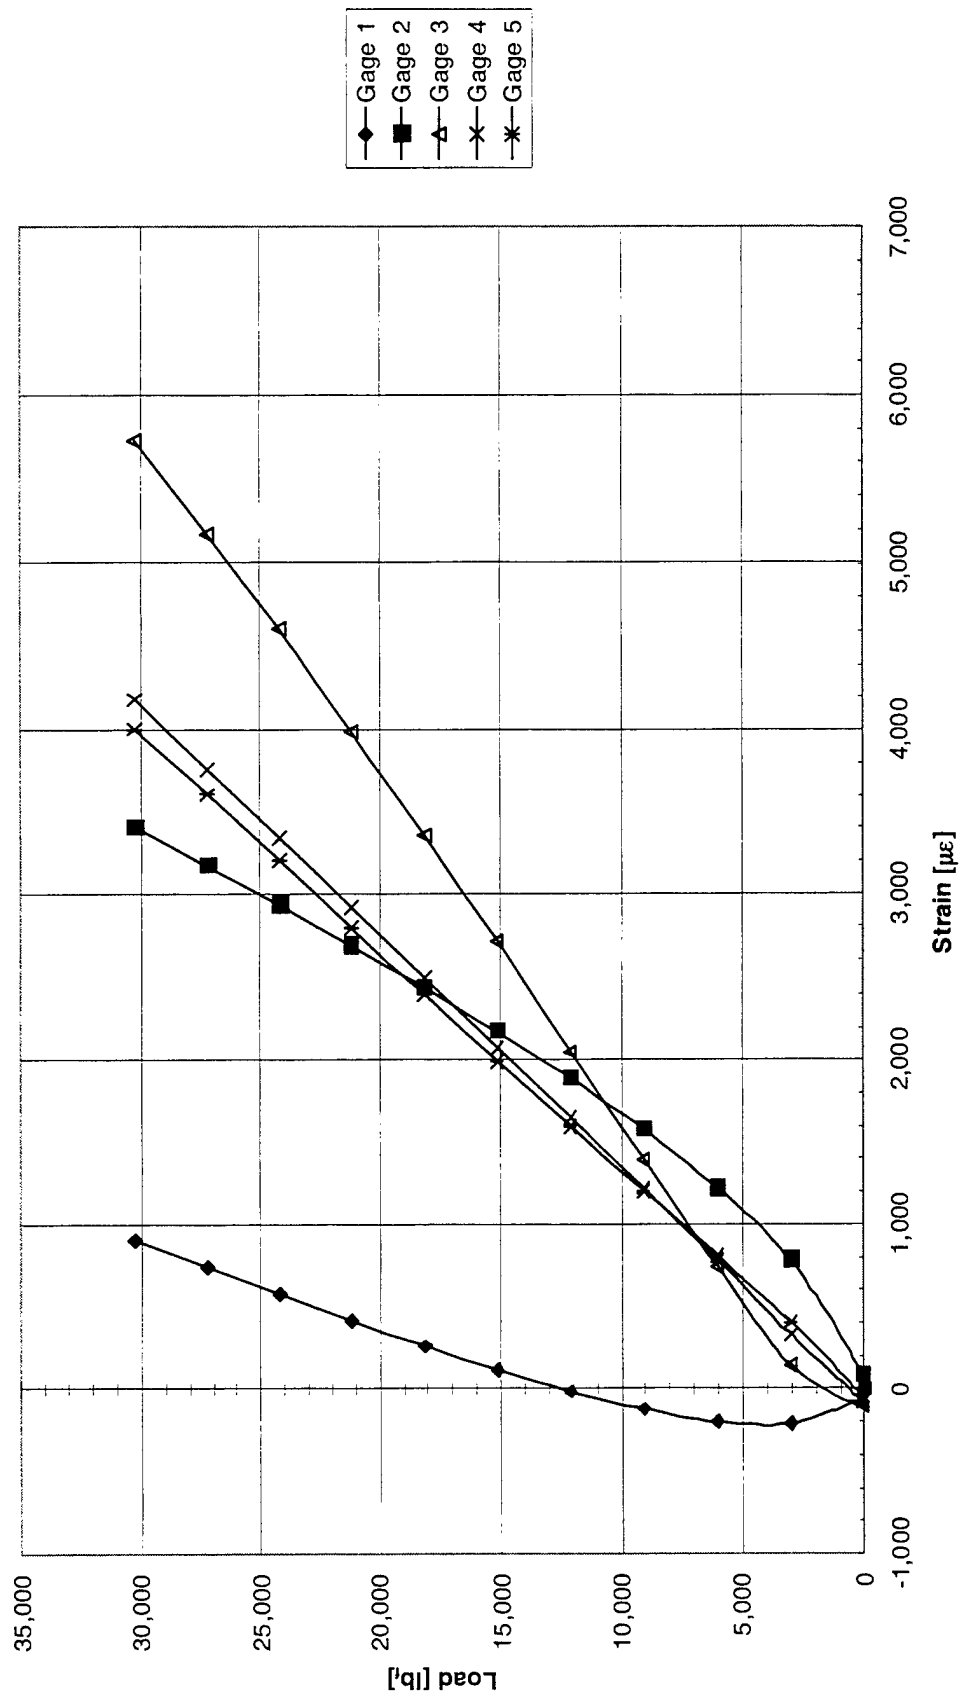
Figure 16. Initial Load-Strain Survey for Panel 123; GBS/BR127 Surface Preparation

Panel 123
0 cycles

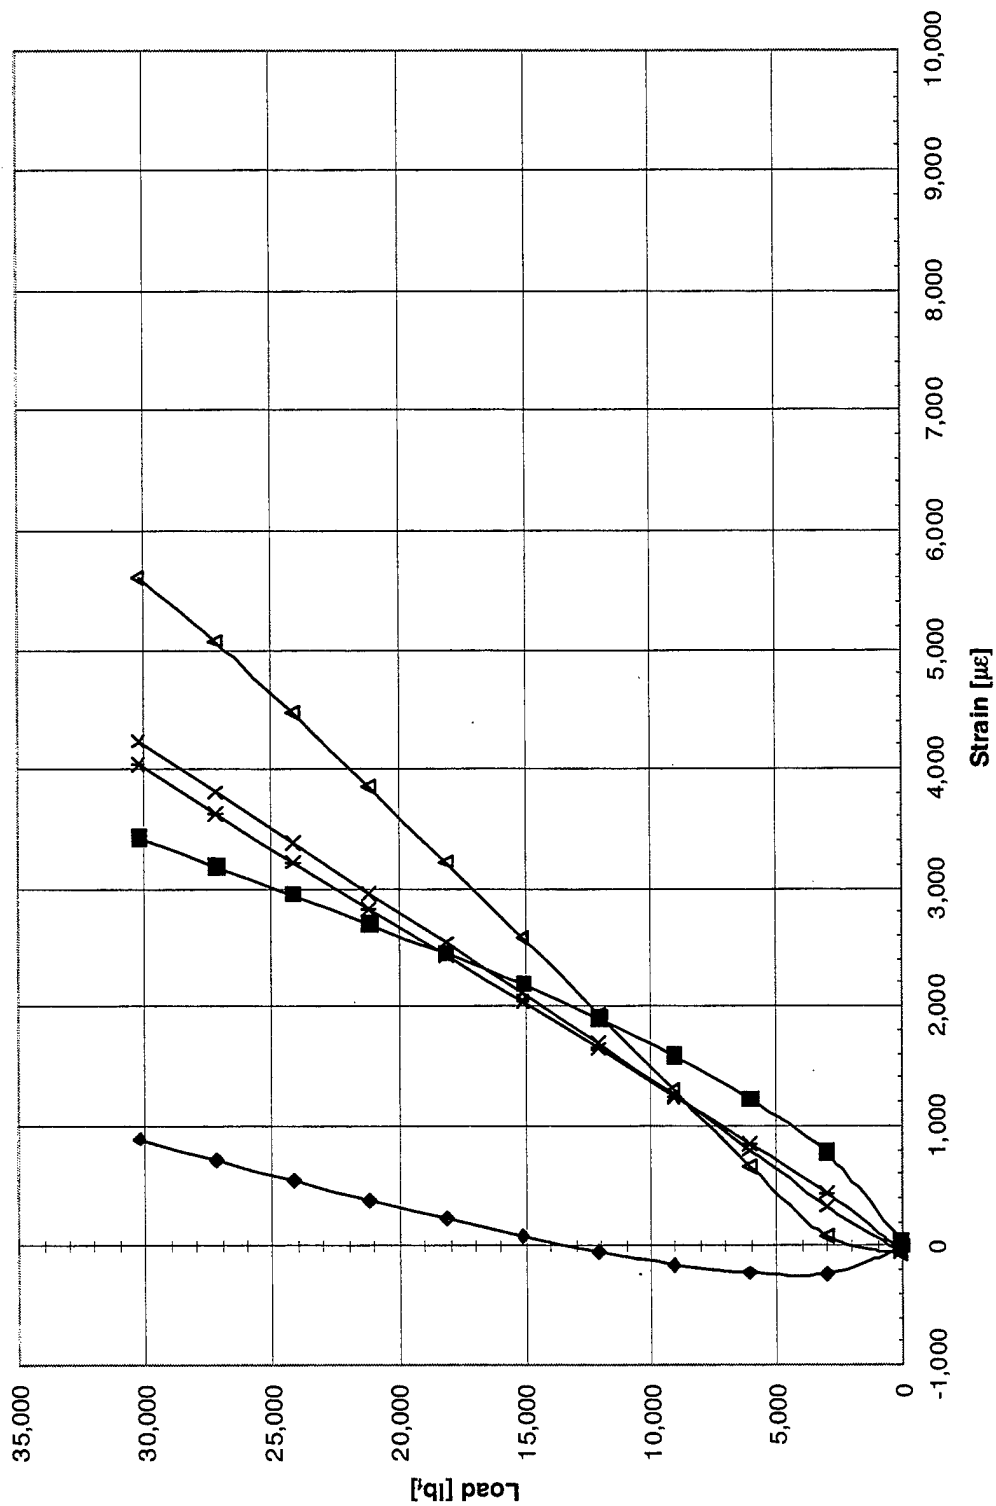
Figure 17. Initial Load-Strain Survey for Panel 125; GBS/BR127 Surface Preparation

Panel 125
0 cycles

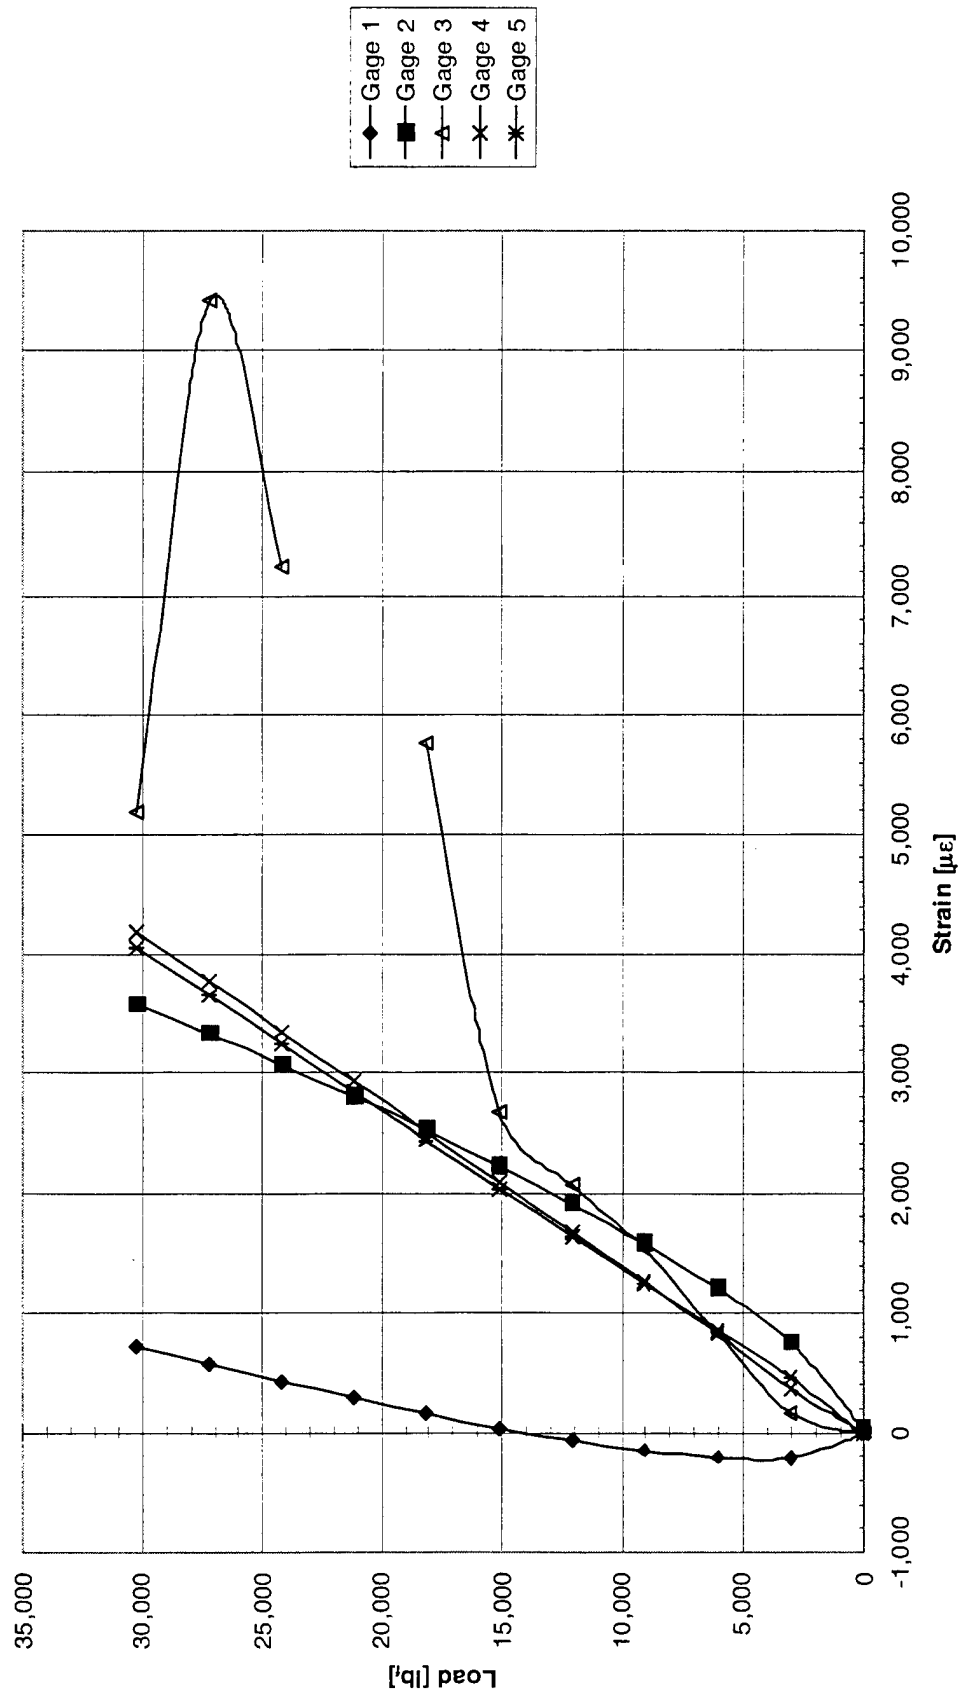
Figure 18. Load-Strain Survey for Panel 125 After 20,000 Load Cycles; GBS/BR127 Surface Preparation

Panel 125
20,000 cycles

Gage 3, which is located very close to the end of the boron patch, exhibits markedly higher strain than the two far-field gages. This is to be expected as a result of the stress concentration that exists at this location. An analysis provided by WR-ALC predicted a stress concentration factor of about 1.27 at the end of the patch used on these panels. At the start of load cycling, the ratio of the strain exhibited by the number 3 gages to that of the number 5 (far-field) gages on the four instrumented panels varied from 1.06-1.2 at 10,000 lb to around 1.4 at 30,000 lb tensile load.

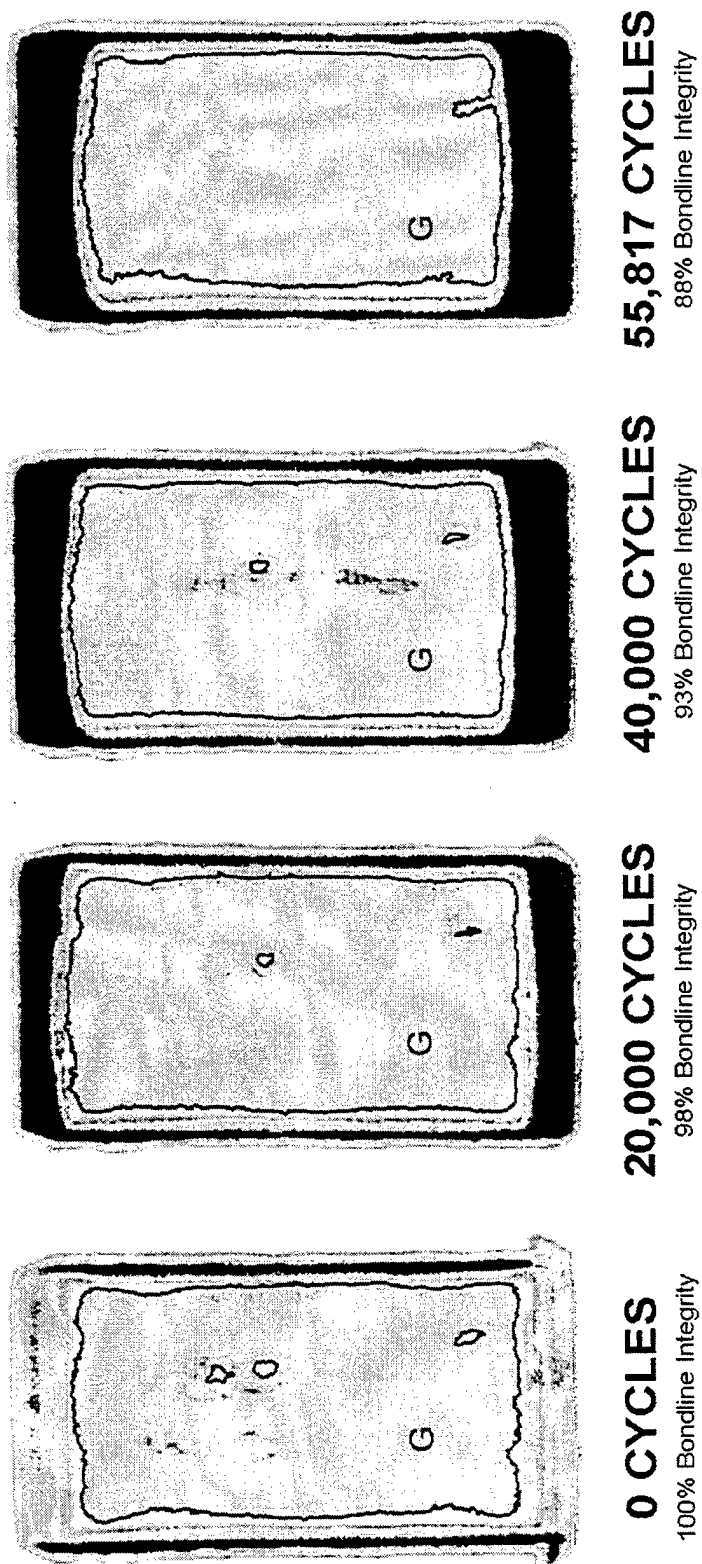
Figure 20. Effect of Fatigue Cycling on Bondline Integrity as Indicated by C-Scans

Specimen No.: 127
Surface Preparation: Grit-Blast Silane/BR127
Test Condition: Room Temperature Dry
Fatigue Stress Ratio: 0.1

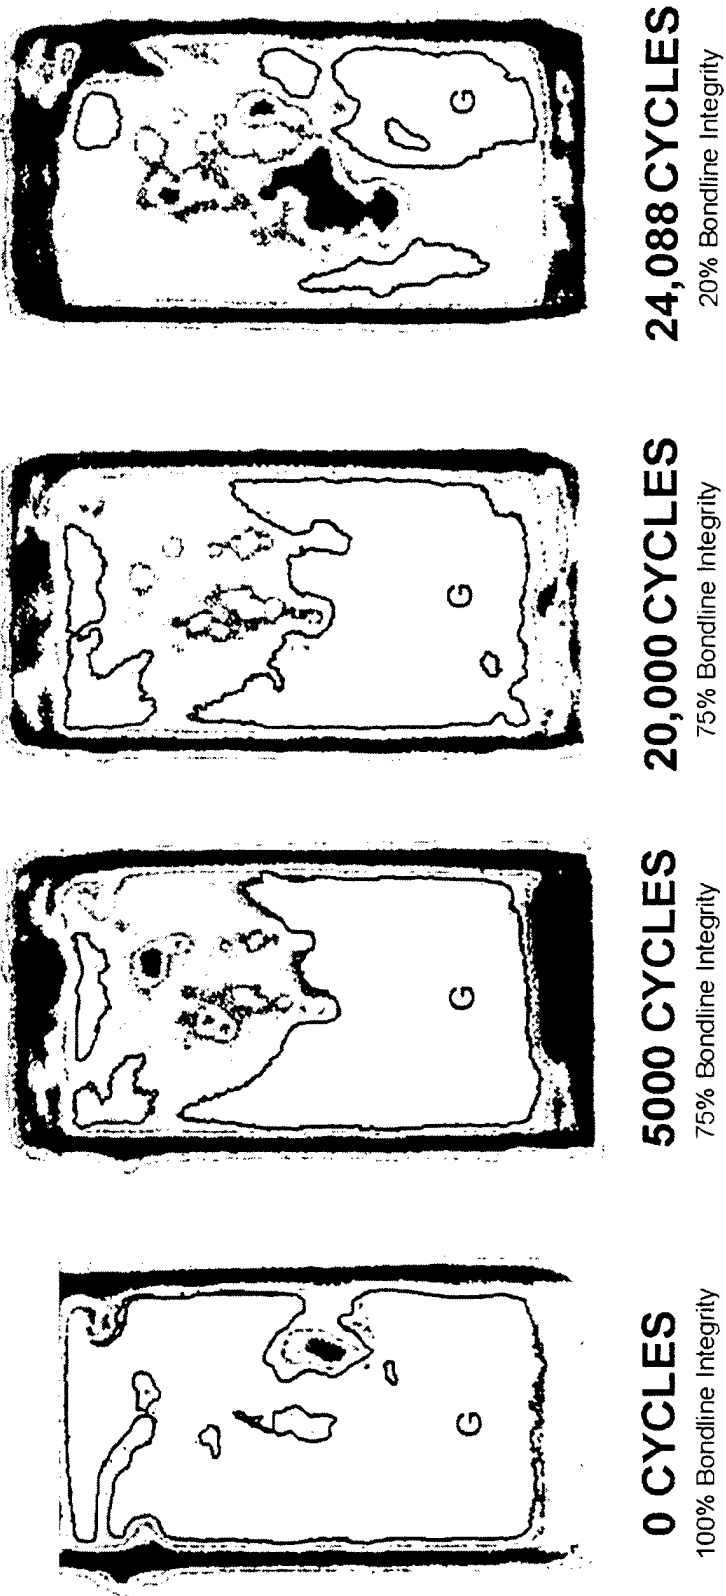
Figure 21. Effect of Fatigue Cycling on Bondline Integrity as Indicated by C-Scans

Specimen No.: 126
Surface Preparation: Grit-Blast Silane/BR127
Test Condition: Room Temperature Wet
Fatigue Stress Ratio: 0.1

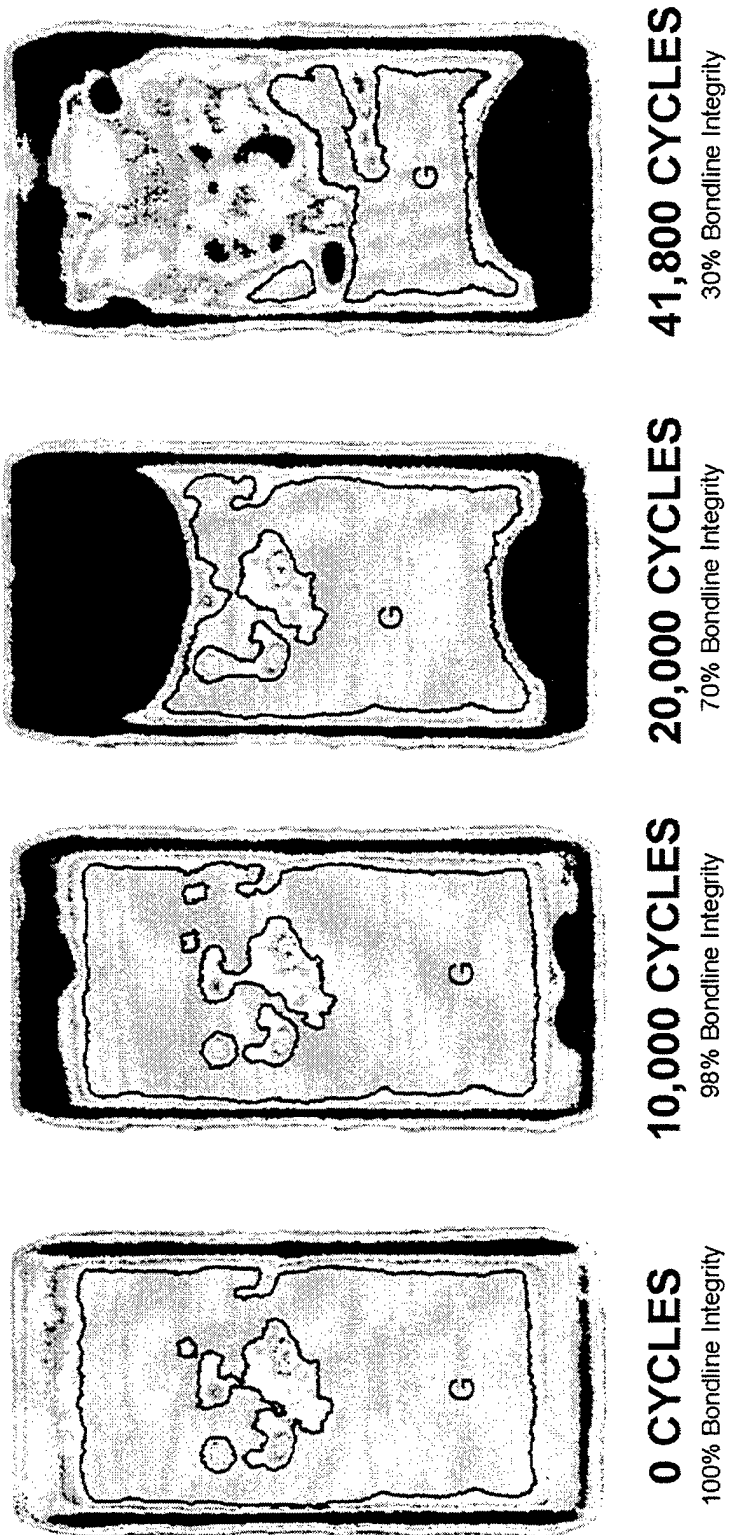
Figure 22. Effect of Fatigue Cycling on Bondline Integrity as Indicated by C-Scans

Specimen No.: 103
Surface Preparation: Scuff-Sand/No Primer
Test Condition: Room Temperature Dry
Fatigue Stress Ratio: 0.1

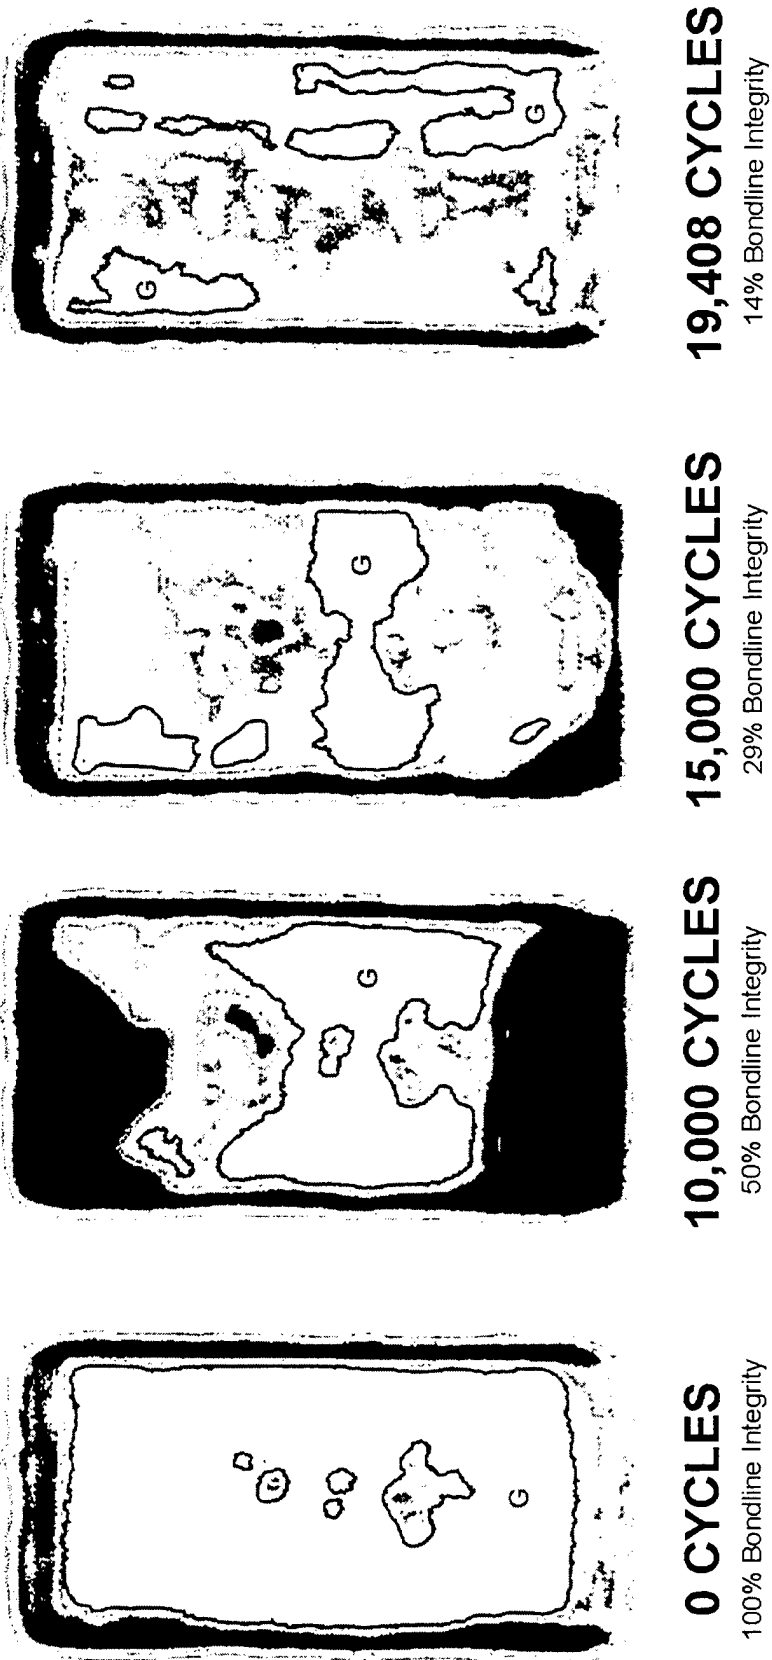
Figure 23. Effect of Fatigue Cycling on Bondline Integrity as Indicated by C-Scans

Specimen No.: 101

Surface Preparation: Scuff-Sand/No Primer

Fatigue Stress Ratio: 0.1

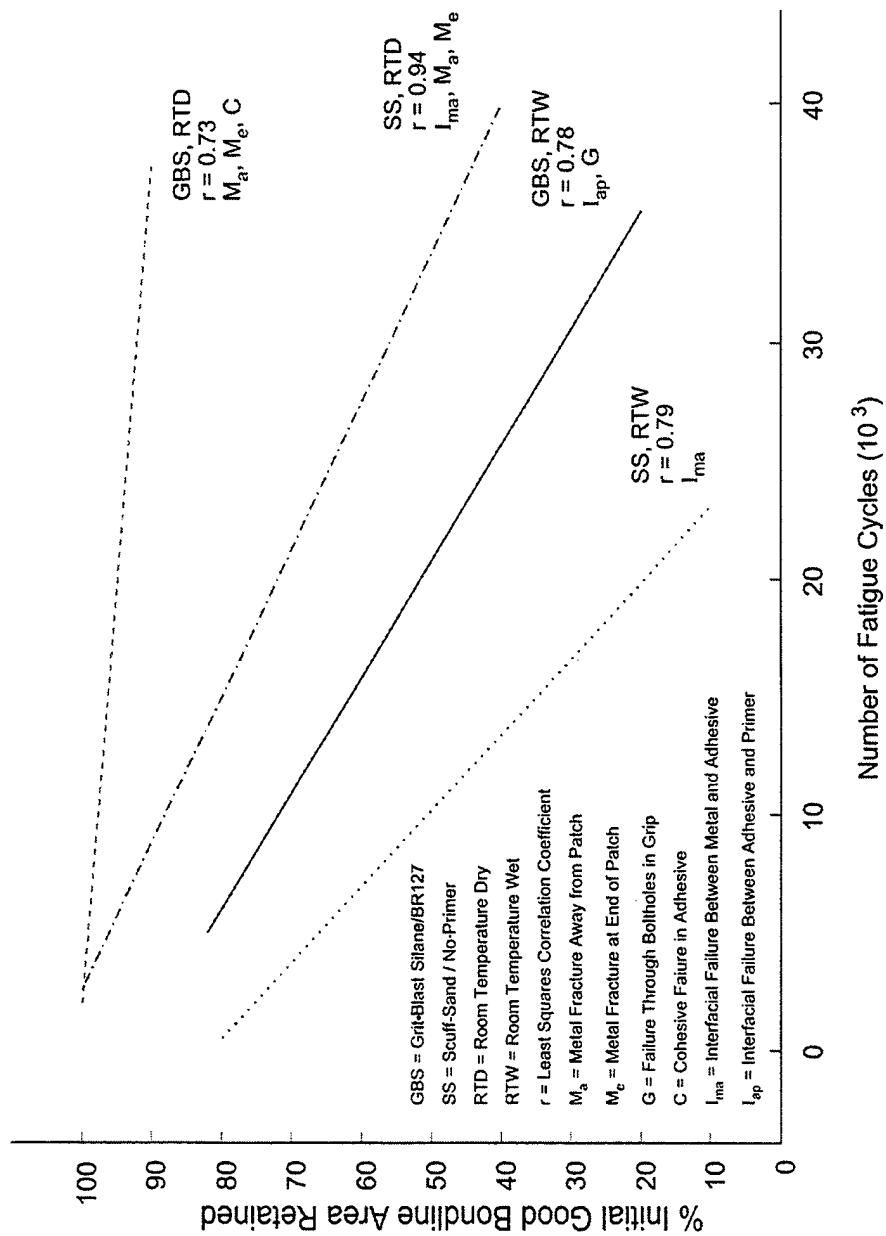
Figure 24. Effect of Fatigue Cycling on Bondline Integrity of Patched Specimens Tested at Room Temperature and at a Stress Ratio of 0.1

For each specimen, the ratio of the remaining good or undegraded portion of the bondline to the original good portion of the bondline was determined at each C-scan inspection. This ratio represents a quantified measure of bondline integrity. Figures 24 through 28 illustrate how this bondline integrity, measured as described above, changes with fatigue cycling for various test conditions. In these figures, the lines plotted for the room temperature-dry and room temperature-wet test conditions at $R=0.1$ represent least-square fits of the data for five specimens each. The values for r given for each line represents the least-squares correlation coefficient. The lines for the other test conditions represent a single specimen each.

Inspection of the curves in Figures 24 through 28 along with the failure modes tabulated in Tables 5 and 6 leads to the observations described in the following subsections.
